## STRUCTURAL FAILURES OF EARTH DAMS IN NIGERIA: A CASE STUDY OF CHAM DAM IN GOMBE STATE

Umaru A.<sup>1</sup>, Ogedengbe K.<sup>2</sup> and Omobowale M. O.<sup>2</sup>

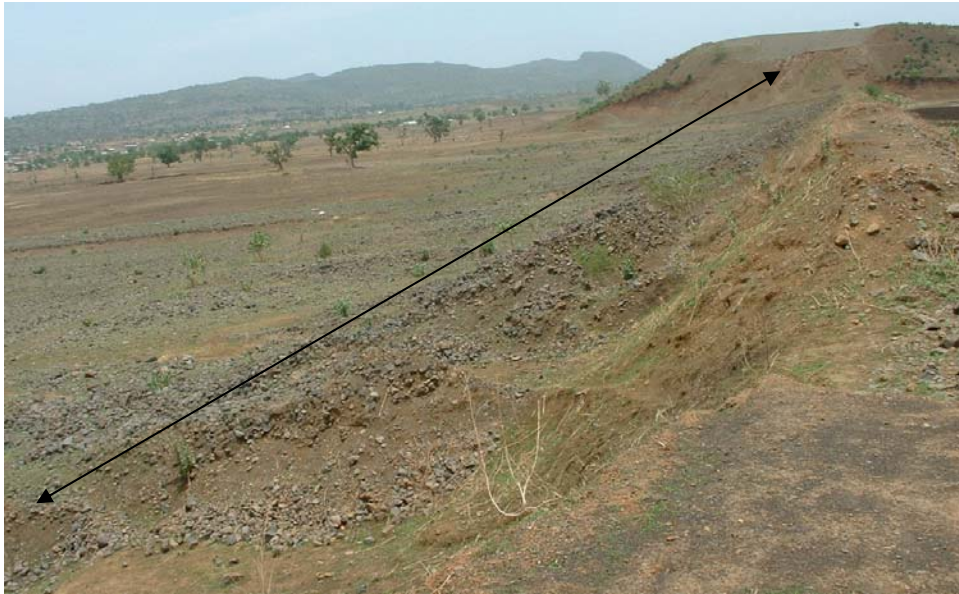
Two design drawings, "UBRBDA-HQ 072/95" and "UBRBDA-HQ 081/96" were found in the records and they manifest marked differences between them. Comparisons between the two drawings show that the crest width was reduced from 10m to 8m; thus reducing the dam's volumetric capacity. Also, there was a replacement of the "toe drain" in one design with a "toe weir" in the other one (Plate-1).

**Plate-1.** Position of toe weir at down stream covered by rubles.

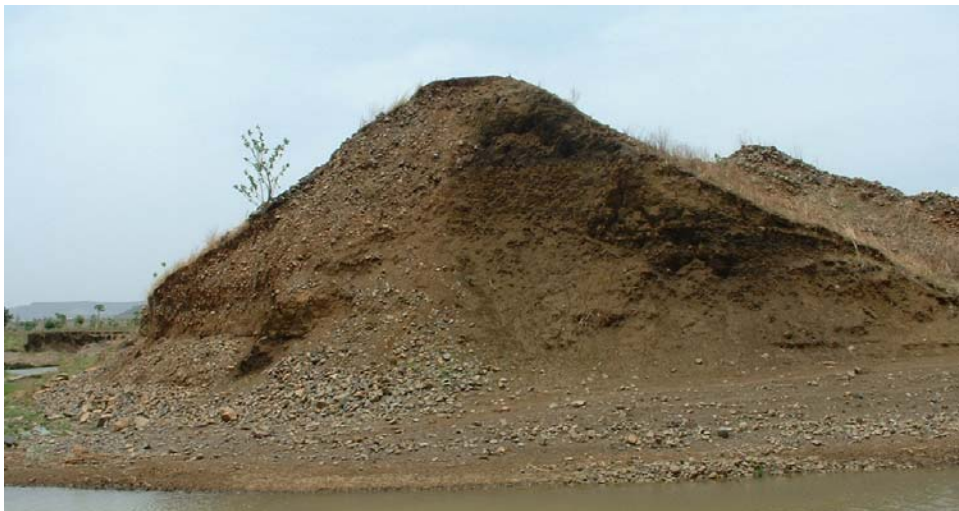
From drawings, it consisted of a zoned dam cross-section having a central impervious core and key trench of the same clay material. The core was bordered by a semi-pervious transition material which was in turn bordered by 'Rubble material' or mass boulders of rocks embedded in clayey soil. It was observed that the breached section of the dam does not seem to have the clearly delineated zones as described on the drawings (Plate-2).

**Plate-2.** A breached section through the dam shows a uniform material.

- k) If highly permeable material would be used at all in constructing the dam, it will be found least objectionable if applied at the outer parts of the dam to aid drainage as a fill. Particularly attention must be given to the use of impervious materials in the core;

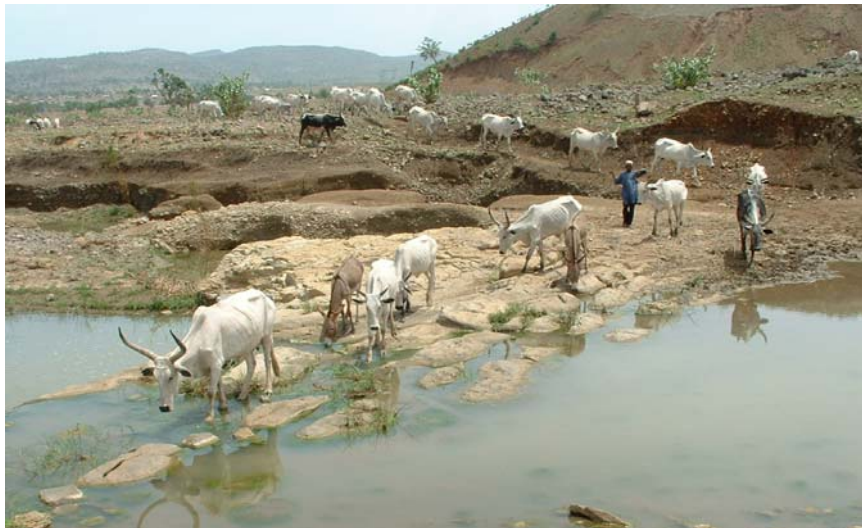
The dam crest was designed to have compacted lateritic material overlying compacted gravel stones. The downstream and upstream faces of the dam were slopped at ratio 3:1 (3 horizontal and 1 vertical) and 2:1, respectively. The key trench was designed to be constructed to as much as 2.5m below original ground surface. Observation at the dam foundation around the breached section does not show any trench at sight. No need for key trench since foundation is rocky (Plate-3).

**Plate-3.** Dam foundation on rocky material not having a key trench.

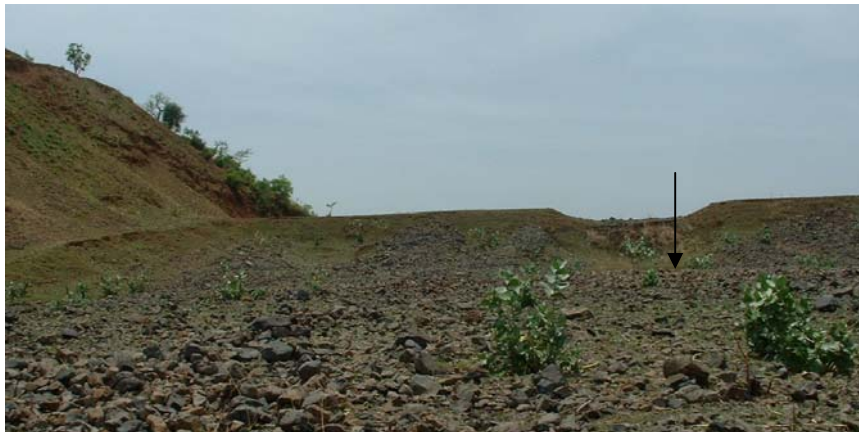
- a) Seepage at downstream dam toe, about 500m away from the right abutment and crest crack.
- b) Land slide at the right abutment of the dam most likely induced by excess pore water pressure in confined soil, weak loose soil triggered by shock vibration, seepage or foundation movement (Plate-4).
- c) Insufficient freeboard (near overtopping)
- d) Incomplete construction of the spillway (Plate-5)
- e) Incomplete construction of the dam crest leaving as it were, a very extensive depression at crest level.
- f) Some farmers impounded water at the upstream side of the dam for use on their farms, only to release the water later with the incoming floods of 1998 thereby resulting in increased volume of water which eventually overtopped the dam.

**Plate-4.** Land slide (Slope failure) near the right abutment.

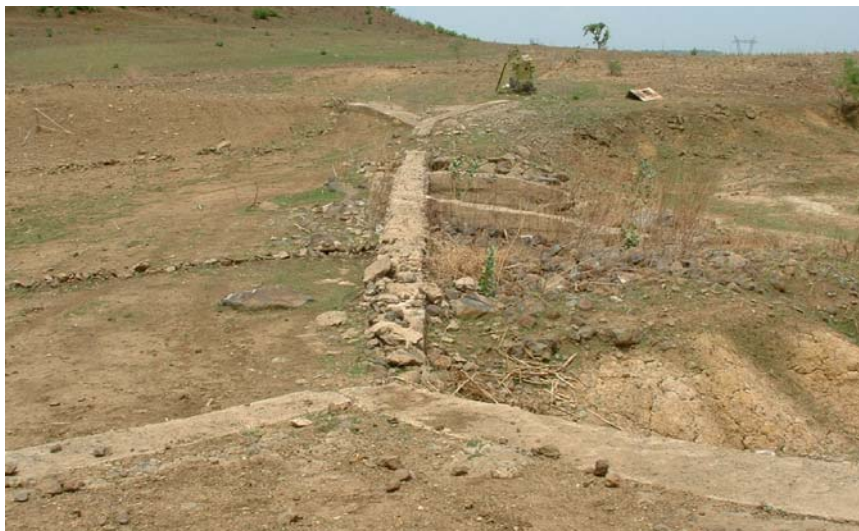
**Plate-5.** Uncompleted Spill-way.

With frequent occurrence of low freeboard otherwise known as "near overtopping", the dam had been frequently endangered. The spillway was reported to have a capacity of 200m<sup>3</sup>/s, while in another report it was to have a capacity of 75 m<sup>3</sup>/s.

- e) Engineering procedure of project conception, implementation operation and maintenance should be strictly adhered to;
- f) There should be a well designed and constructed spillway;

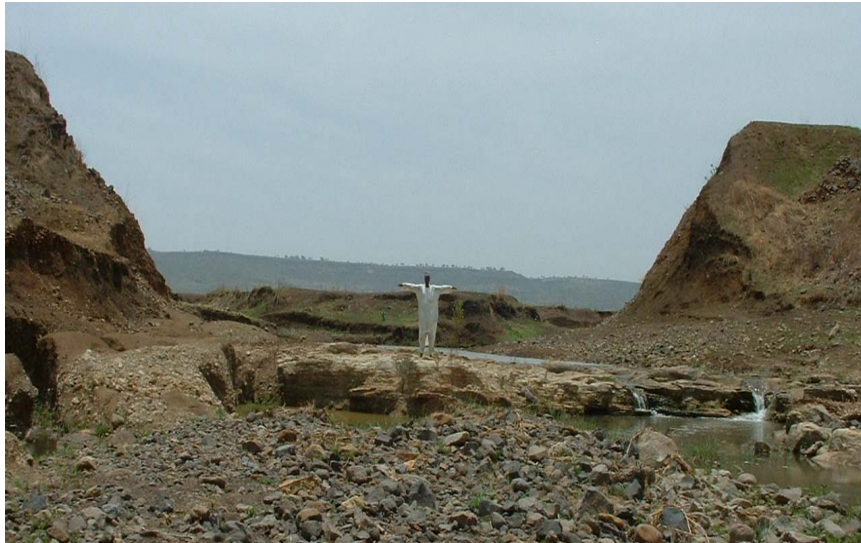
- a) Hydraulic failure - Overtopping and near overtopping.
- b) Seepage failure - Piping at downstream toe of the dam.
- c) Structural failure - Cracking at various points on crest, settlement near the right abutment and complete breach of the embankment (Plate-6).

**Plate-6.** Complete failure of the dam.

The toe seepage occurred near the right abutment approximately at the location where the Cham river tributary crosses the dam axis. This is also the location where the present dam breach cut the dam at its lowest. It was observed that the irrigation release facility was too

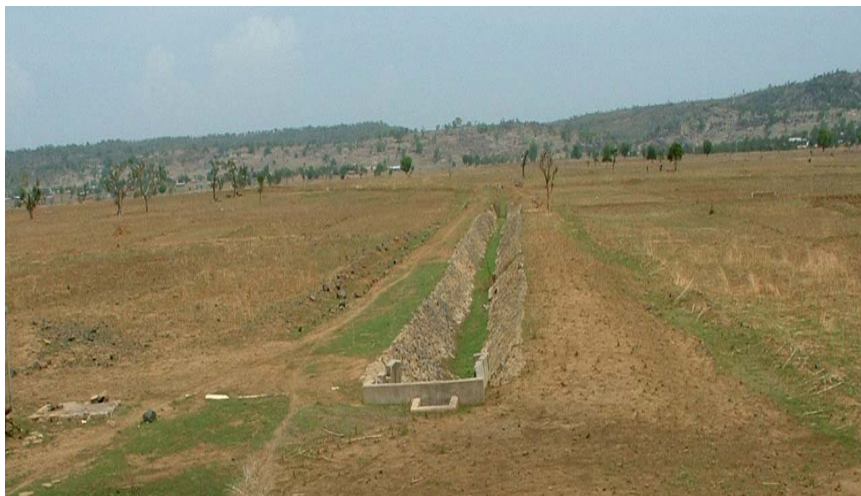
small to make any significant discharge to curtail the incoming floods of 1988. Even when the facility was set at maximum discharge, the flood was far greater than the discharge due to the facility. (Plate-7).

**Plate-7.** Exit of the Main Canal from the release facility.
