MANAGEMENT OF RISK THROUGH SEEPAGE REDUCTION FOR TWO EARTH DAMS IN KURDISTAN REGION, IRAQ

Sangar Hasan Abdulkareem, Thamer Mohamed Ahmed and Abdul halim Ghazali

Department of Civil Engineering, Universiti Putra Malaysia, UPM Serdang, Selangor, Malaysia

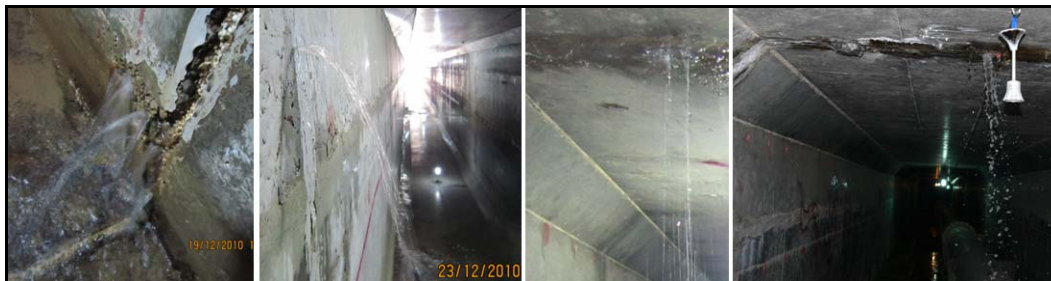
Evidence of seepage problems at Bawashaswar dam appeared during the first filling of the reservoir in January 2011 when a high seepage rate was recorded at the expansion and construction joints of the outlet gallery

(Figure-3) particularly at the expansion joints of gallery walls which are located under upstream shell zone. Also seepage was observed at the downstream flat slope beside the stilling basin (Figure-4).

Figure-3. Seepage at the expansion and construction joints of the outlet gallery of Bawashaswar dam.

Based on photographs during modifications of the dam, the main causes of the seepage at the bottom outlet gallery are construction defects and floods. Two major floods had occurred at the site of Bawashaswar dam during the construction of the bottom outlet gallery which was used as a diversion channel during construction of the dam. As a result of these floods, the dam site was covered with silt deposition and the rubber used in the expansion and construction joints to control seepage was damaged as shown in Figure-12.

Also, it was found that the same type of rubber used in the expansion joints was used in the construction joints too (Figure-13). As a result, any rupture or punch in the rubber will develop a path for water leakage from these joints.

In addition, poor construction of these joints increases the probability of leakage. Furthermore, fractures were observed along the gallery which was wet at upstream side, while residues of seepage were found at the dam downstream side as shown in Figure-14.

As mentioned previously, the main causes of seepage problems at the outlet gallery wall are construction defects and floods. The rubber used in the horizontal construction joints to control water seepage was designed to be used at expansion joints. Punching of rubber joint will develop water path along the joints. Flood event and differential settlement of gallery led to the rupture of the water-stop and seepage developed along the gallery. In addition, many cracks were developed at the structure of the gallery due to the differential settlement. However, for cracks that have leakage within low hydrostatic pressure, grouting the crack by injecting either a rigid epoxy mortar or an elastomeric filler (if crack movement is anticipated) are recommended, while for cracks that have leakage within high hydrostatic pressure, installation of a drainage system may be necessary. Generally, the hairline cracks in concrete are not considered as a hazardous problem unless the cracks open up (DNR, 2007; MDE, 2003; NCDENR, 2007). Then, for tackling the downstream flat slope seepage problem, grouting the recent deposits stratum by injecting cement bentonite is recommended for reducing the seepage rate (USACE 1993).

on dam safety. For containing these problems, as the first step, the authority should repair the joints at bottoms outlet gallery wall, and next step to grout the recent deposits at downstream foundation of the dam. This is because grouting the recent deposits stratum will lead to the rise the level of phreatic line and will increase the seepage problems at the bottom outlet gallery.

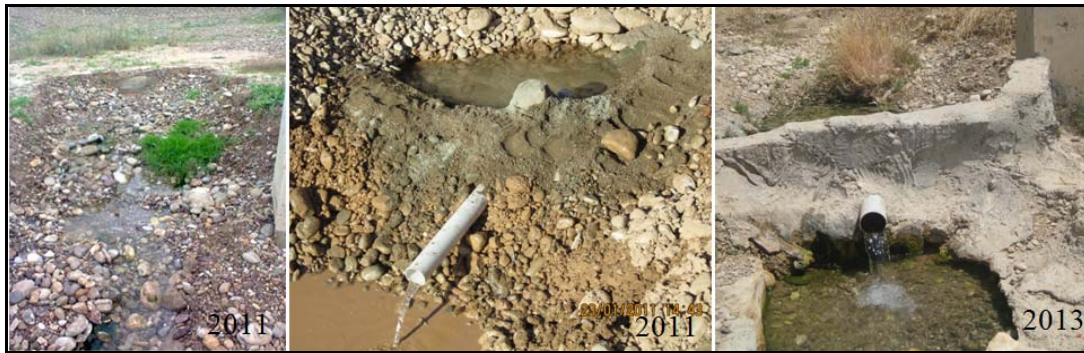
Figure-4. Seepage at the downstream flat slope of Bawashaswar dam.

The grouting has not been done at the joints of the bottom outlet gallery wall that were located under downstream shell embankment. This is because small seepage rate was observed at these joints which occurs during rainy days. Thereby, with treatment of recent deposits the phreatic line elevation will rise and water will seep through all these joints and lead to a catastrophic dam failure event. Earth fill materials that surround the conduit (bottom outlet gallery) will be eroded with developing preferential flow paths through conduit joints, and in most probably it leads to piping phenomenon (NZSOLD, 2000; FEMA, 2005; USB, 1987). Thus, before taking any action for solving the downstream flat slope seepage, the problems associated with joints of bottom outlet gallery must be solved.

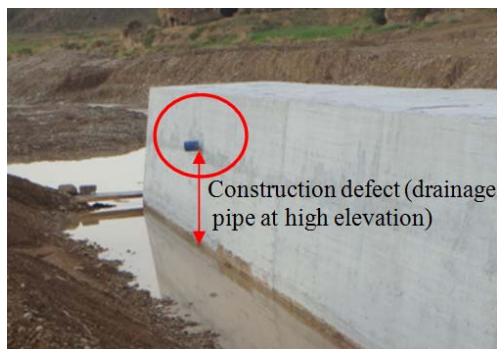
Later, after filling the reservoir, seepage was visually observed at the right abutment of Bawashaswar dam. To overcome the seepage problem at the right abutment, an extensive grouting was performed in the bedrock. As a consequence, the seepage problem at this area has been contained. To mitigate the seepage problems at the joints of the bottom outlet gallery, another extensive cement-bentonite grouting was performed through the wall of the gallery and Sika was used for joints treatment. As a result, the seepage rate was reduced by than 80% and became about 0.5 l/s. However, the seepage problem at the downstream flat slope remains without solution. And the maximum recorded seepage rate at downstream flat slope is 1.8 l/s at the maximum reservoir elevation. Moreover, the drainage arrangement at Bawashaswar dam is not functioning because the drainage pipe has been constructed at a high elevation as shown in Figure-5.

Figure-5. Location of the drainage pipes at Bawashaswar dam.

At Bawashaswar dam, SEEP/W model indicated that the recent deposit at downstream foundation worked as a blanket filter. And this stratum increased the seepage rate by about 21%, and the pore water pressure drop below the drainage elevation. Generally, seepage rate increases within blanket drain and it is used to drawdown the phreatic surface (Fell *et al.*, 2005). To seal geologic defects, grouting of the foundation was recommended which also reduces underneath seepage rate (USB, 2011, Fell *et al.*, 2005). But even if dam downstream is grouted or a barrier is constructed at the dam toe in order to raise phreatic line, the drainage system will be partially working because drainage pipe was constructed at high elevation (Figure-5).

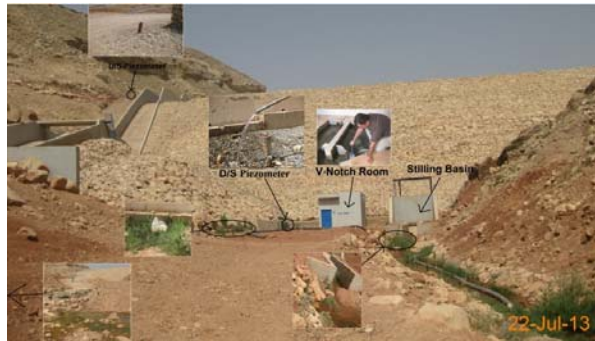
Similar to Bawashaswar dam, evidence of seepage problems was observed during the first filling of the reservoir when a 9 l/s of total seepage rate was recorded at the v-notch weirs and downstream flat slope at Hamamuk dam. The seepage rate declined with time to be 4.4 l/s of a steady rate of total seepage at Hamamuk dam when the reservoir was at an elevation of 804.0 m which is the maximum reservoir elevation. In March 2014, about 1.6 l/s of the seepage was continuously discharging from the downstream piezometer and approximately 1.8 l/s and 1.0 l/s were discharging from left and right v-notch weirs respectively. In addition, many spots of wet areas were observed at the flat slope at downstream as shown in Figure-8.

Figure-8. Seepage at Hamamuk dam site.

The underneath seepage at Hamamuk dam became evident since the first days of initial filling as shown in Figure-8. SEEP/W model indicated that 30 % of the total seepage occurred underneath the dam embankment. This ratio is in agreement with rate of seepage at downstream flat slope area. Generally, grouting was recommended for controlling underneath embankment seepage, but in case of steep abutment slopes (like Hamamuk abutments slopes as shown in Figure-6), grouting has the potential for causing difficulties and possibly can do more harm than good. Therefore, care must be taken when grouting in the abutment to avoid displacements within the rock mass (USACE, 1993).

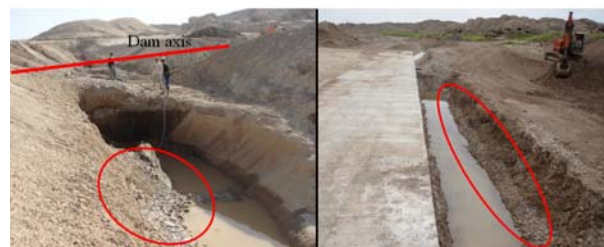
Reviewing construction photographs identified that part of the dam at downstream (from S15 to S17 as shown in Figure-2) was built on boulder and sandy gravel filter (recent deposits) as shown in Figure-9. This stratum is located 2.5 m below the drainage pipe at the dam toe. And the recent deposits stratum that is located beneath bottom outlet gallery with 2 m to 3 m thickness has been replaced by rock concrete.

SEEP/W model was carried out to find the effects of this stratum on seepage path through and beneath the dam and another condition was simulated where the recent deposits are not considered in the dam body. The result indicated that during filling of the reservoir, the recent deposits was worked as a blanket filter at the dam downstream as shown in Figures 10 and 11. As a consequence, the drainage arrangement is not functioning because the drainage pipe is located at an elevation higher than the phreatic line.

Figure-9. Recent deposits at downstream shell foundation of Bawashaswar dam.

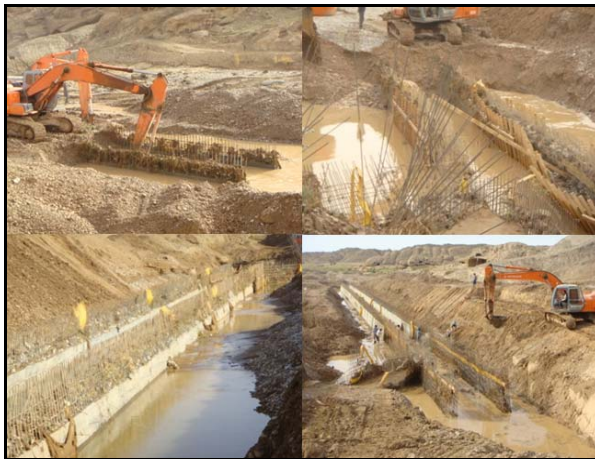
Figure-12. Effect of flood on bottom outlet gallery of Bawashaswar dam.

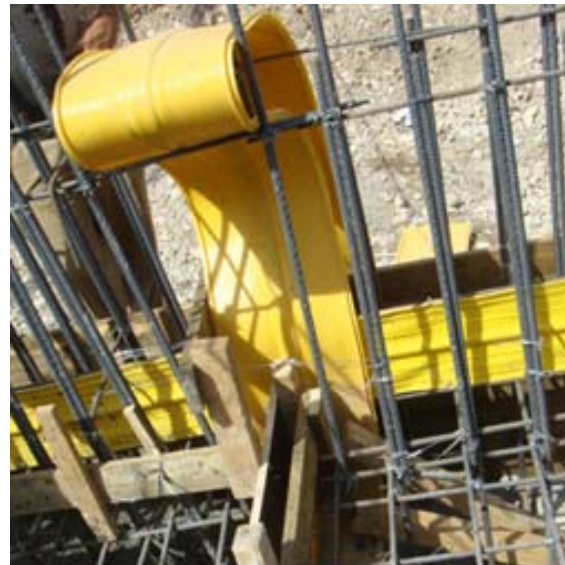
Figure-13. Rubber of expansion joints used for construction joints in the Bawashaswar bottom outlet gallery.

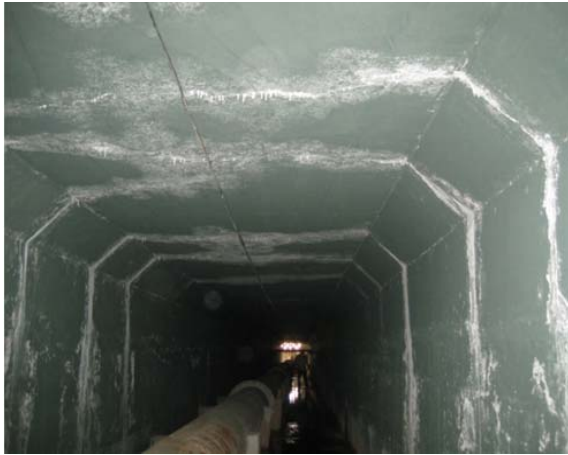
Figure-14. Residues of seepage at fractures along the bottom outlet gallery.

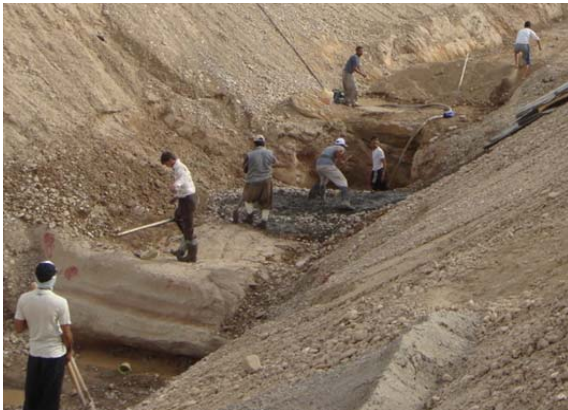
When concrete conduits are placed on non-uniform foundation, differential settlement will occur and this will result in cracking of concrete, opening the exit joints, and rupture the waterstop (FEMA, 2005). At downstream part of Bawashaswar dam, excavations of recent deposits were made at the gallery foundation and it was replaced with rock concrete within different thickness (from 1 m to 3 m thick) as shown in Figure-9 and Figure-15. This was increased the potential for differential settlement and cracking the concrete.

Figure-15. Foundation treatment of bottom outlet gallery at Bawashaswar dam.

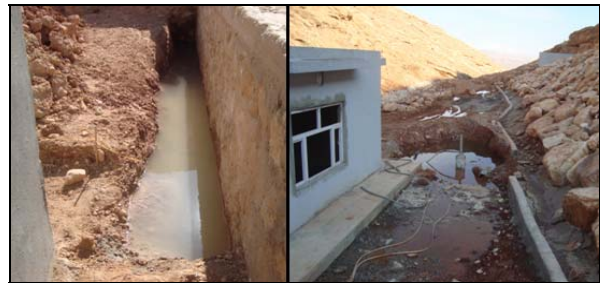
As mentioned previously, the main function of the dam is for recharging the groundwater and based on this, the dam was constructed on an area with high permeability. However, grouting was not included in the dam design. Nevertheless, reviewing construction photographs identified that during initial filling and within dead storage reservoir elevation, water was discharged through a drainage pipe at the tail of the dam. Moreover, flooding was observed at the dam tail behind the retaining wall as shown in Figure-16, which confirms the high seepage recorded rate at Hamamuk dam.

Figure-16. Seepage at Hamamuk dam during initial filling.

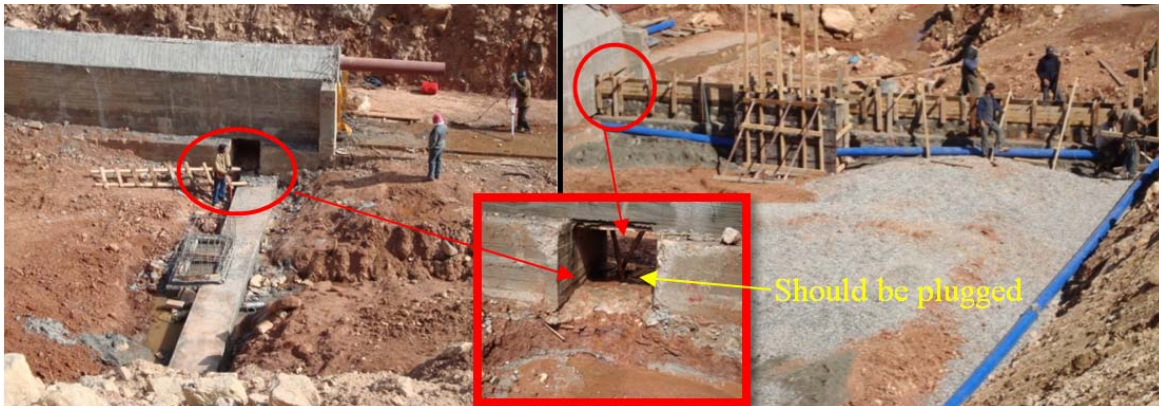
The drainage system is designed to separate the seepage of the dam's left side from the seepage of the dam's right side along the diversion channel as shown in Figure-7. But it is found that the design was not working and the seepage from both sides is mixed due to construction defects as shown in Figure-17.

Figure-17. Defect at drainage system of Hamamuk dam.

Regarding the defects at drainage system, the problematic area can be excavated and plugging the open area in order to separate seepage at left side of the bottom outlet from right side and it can help to locate the seepage problematic area.

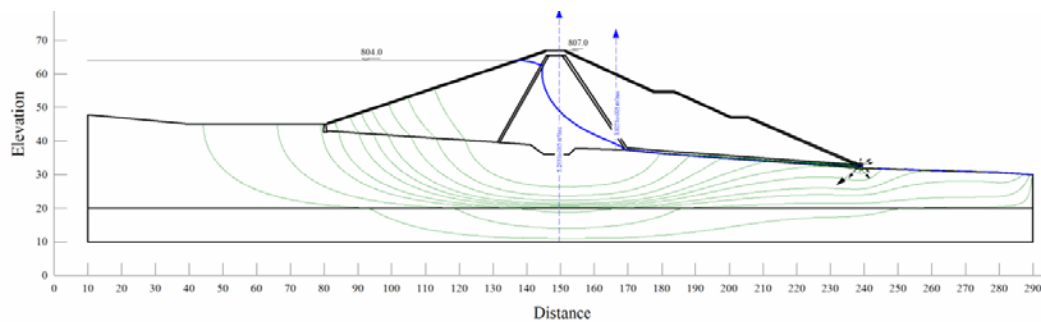
SEEP/W model was employed to find the seepage path and rate through and beneath the dam. The maximum elevation of the reservoir used in the simulation of seepage is 804.0 m as shown in Figure-18. As a result, the seepage simulation shows that about 30% of the total seepage is occurring underneath the dam embankment.

Figure-18. Modeling of pore-water pressure and seepage rate of Hamamuk dam.

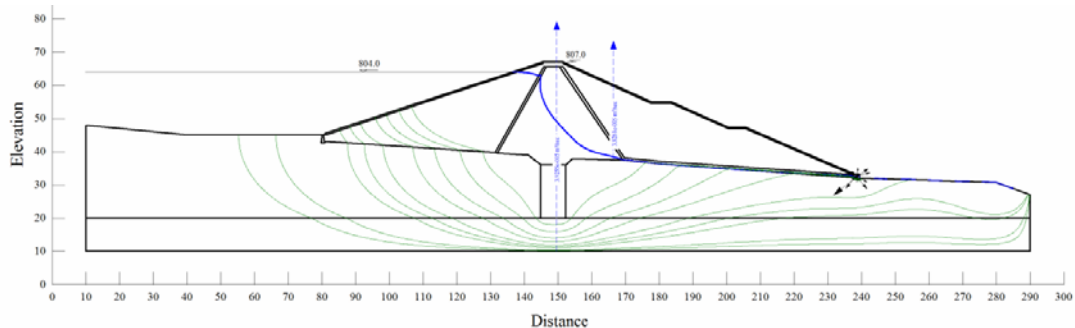
In order to control the underneath seepage, grouting of foundation was recommended (USBR, 2011; USACE, 1993; Rice, 2007). Also, SEEP/W model was employed to simulate the effectiveness of the grouting to reduce seepage rate as shown in Figure-19. Results show that the seepage rate can be decreased by about 30%.

Figure-19. Modeling of pore-water pressure and seepage rate of Hamamuk dam within grouted foundation.
