INVESTIGATION OF PHOSPHATE (PO_4^{-3}) AND AMMONIA-NITROGEN ($\text{NH}_3\text{-N}$) CONCENTRATIONS AT SOME SELECTED LOCATIONS OF THE MALNICHARA CHANNEL AND THE SURMA RIVER

Rezaul Kabir Chowdhury and Sheikh Istiak Mohammad Ali

Department of Civil and Environmental Engineering, Shahjalal University of Science and Technology, Sylhet, Bangladesh

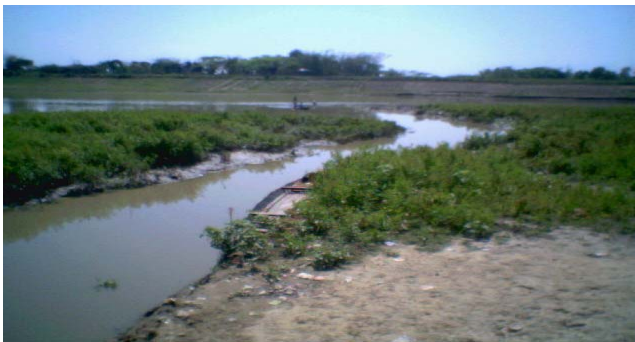
Figure-2. Off take point of Malnichara channel to Surma River.

Sampling locations are shown in Figure-1. Picture of off take point of Malnichara to Surma River is shown as Figure-2.

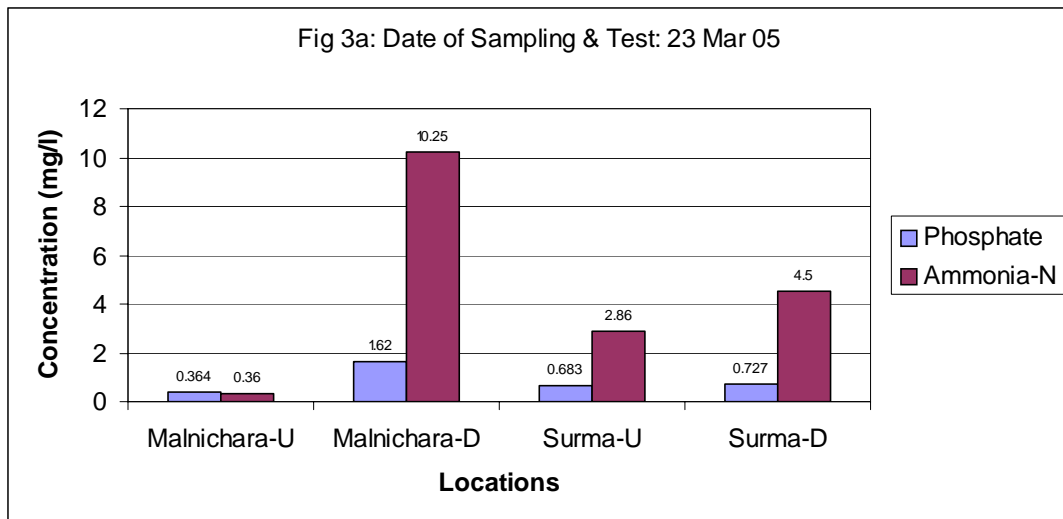
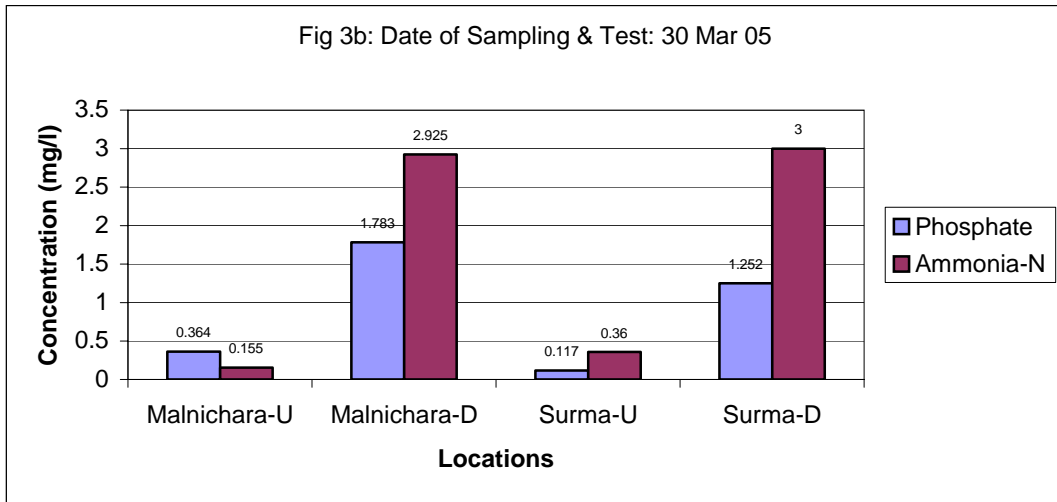
Figure-3 (a, b, c, d, e). Variations of phosphate and ammonia-nitrogen.

For recreational, fishing and irrigation purposes, DoE (1991) environmental quality standards are 6 mg/l, 10 mg/l and 10 mg/l, respectively. In all four locations, phosphate (PO_4^{-3}) concentration does not exceed the standard. However, from Choukidekhi to Topoban, concentration increased in Malnichara channel. In the Surma River, concentration of phosphate also increased from upstream to downstream of Malnichara off take.

DoE (1991) standards of ammonia nitrogen for various purposes are drinking water (0.5 mg/l), recreational water (2 mg/l) and fishing water (0.075 mg/l). Concentration of ammonia nitrogen in Malnichara channel is tremendously increased from Choukidekhi to Topoban in both dry and after rainfall conditions. At the downstream of Malnichara off take, concentration of NH_3-N in Surma River is increased. Concentration of NH_3-N in Malnichara channel and Surma River exceeds DoE standard for fishing and recreational purposes at Topoban and downstream of Malnichara off take, respectively. Variations of phosphate and ammonia-nitrogen are shown in Figure-3 (a, b, c, d, e).

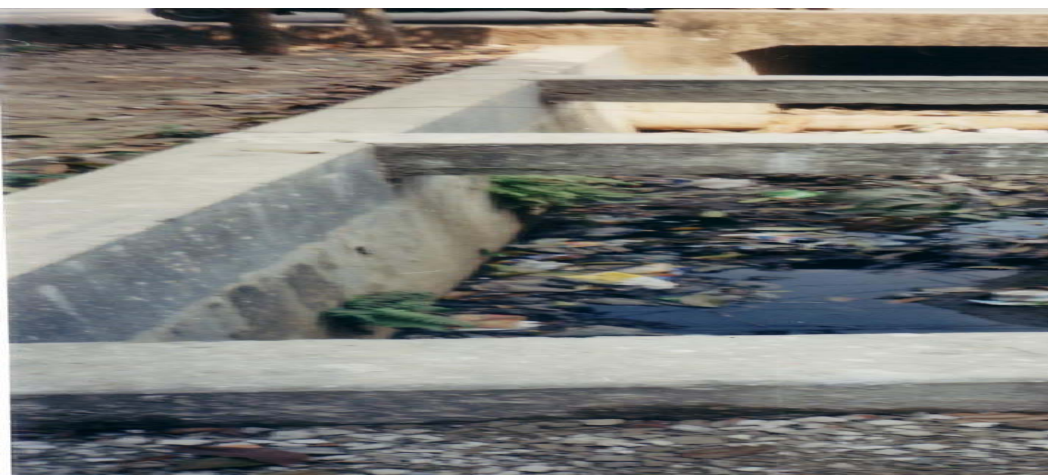
Figure-4. Drain blocked by solid waste at Pathantula.

At present, a total of 180-200 tons of solid waste is generated in the Sylhet city and only 140 – 160 tons are collected (Chowdhury, 2005). Uncollected waste is washed out to the roadside drains and natural canals. Blockage of drains by solid waste reduces the carrying capacity of drains and natural canals and also a source of pollution. Figure-4 is a picture of drain blocked by solid waste.

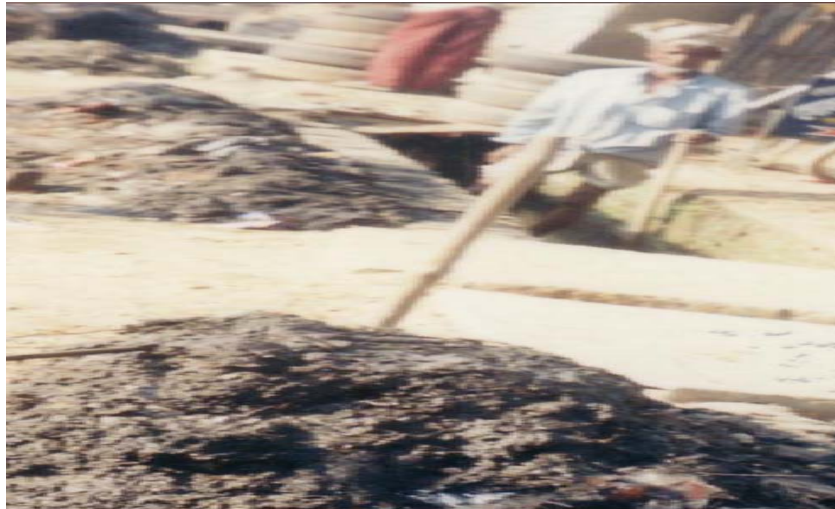
Figure-5a. Garbage stored along the street during cleaning (Subid Bazar).

Sylhet City Corporation has very limited resources to clean the drains. A fixed labour has been assigned for each ward to clean the drains. Drains are cleaned at an interval of 8 – 10 days. During cleaning, garbage is stored beside the drain and it has been reported by local people

that stored garbage are not collected regularly. As a result, during rainfall garbage are washed out to the drains again. Figure-5 (a, b) shows the pictures of stored garbage beside the drain.

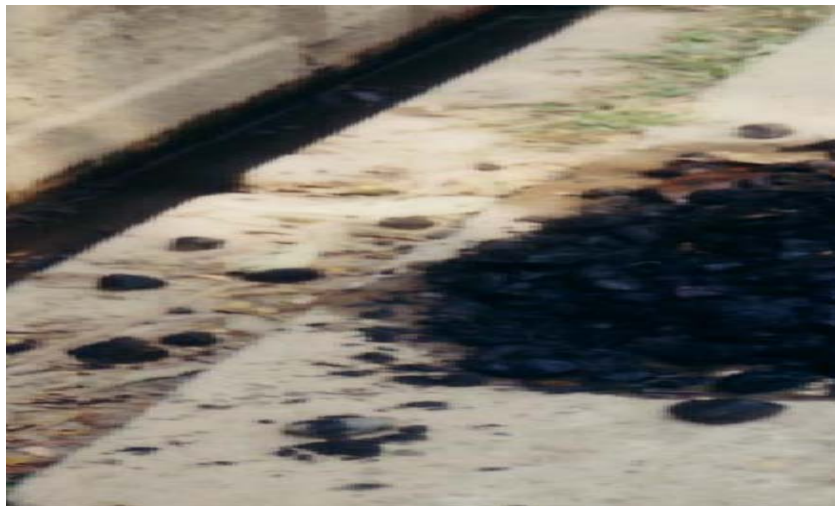
Figure-5b. Garbage stored along the street for a long time (Londoni Road).
