# PERFORMANCE OF THE SACRIFICIAL GALVANIC ANODES IN REHABILITATION OF MARINE STRUCTURE AT PORT BLAIR, ANDAMAN AND NICHOBAR ISLANDS, INDIA

V. Rajendran<sup>1</sup> and R. Murugesan<sup>2</sup>

<sup>1</sup>NDT Consultancy and Services, Chennai, India

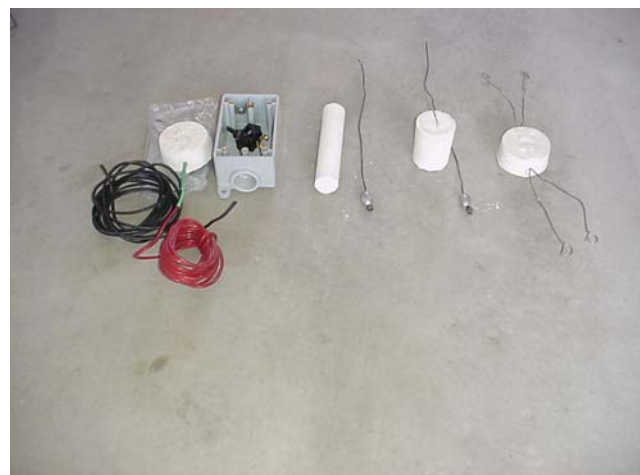
The heart of the devices is a metallic anode composed of zinc, which is cast around a pair of steel tie wires. This unit is encased within a cementitious shell. The device is shaped like a short cylinder, about 2.5 inches in

**Figure-5.** Typical view of the galvanic anodes and monitoring box.

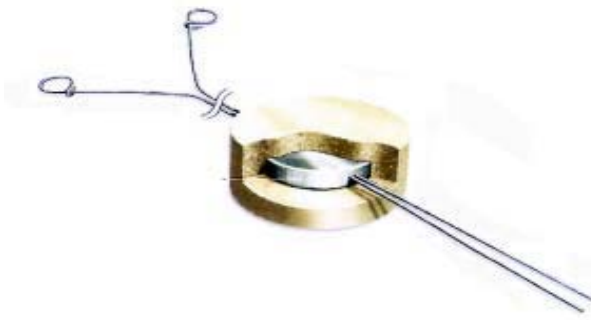
**Figure-6.** Typical cut-away view of galvanic anode.

As the zinc corrodes, it releases a supply of electrons. This electrical current travels through the tie wires, into the surrounding reinforcing steel to reduce new corrosion activity on the steel. The output from the anode will vary according to a number of variable including concrete resistivity, moisture content, temperature, and reinforcing steel density. In the same way that climatic variations will affect the degree of corrosion in an unprotected structure, the environment into which the anode is installed will have a large influence on its current output. In humid and/or warm climates the anodes tend to corrode more aggressively than in cool and/or dry regions. There, fluctuations in the current output of the anode will vary with changes in the corrosion activity of the steel. The conditions that exist within the concrete will also influence the output of the anode. The permeability, chloride content, pH, conductivity, and steel density within the concrete will all affect the anode current output. The more severe the situation, the more aggressive the corrosion will be if anodes are not installed. By embedding galvanic anodes within the repair, the anodes provide galvanic protection, thereby reducing the tendency for the steel in the adjacent area to corrode.

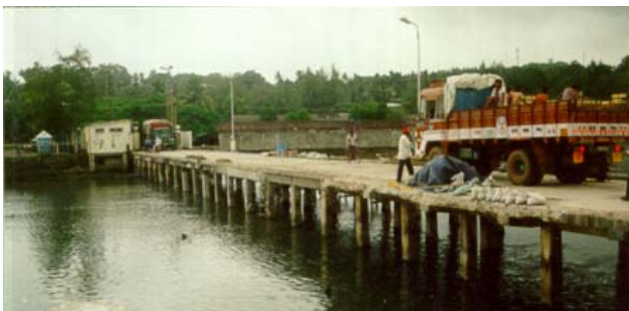
Figure-8. A view of the corrosion affected fisheries jetty approach.

Based on the analysis of the test results, a repair methodology was proposed to be adopted for the piles and beam. It was decided to take additional care for the corrosion problem by implementing some new technology and not only application of some protective coating to the rebar after removing the contaminated concrete.

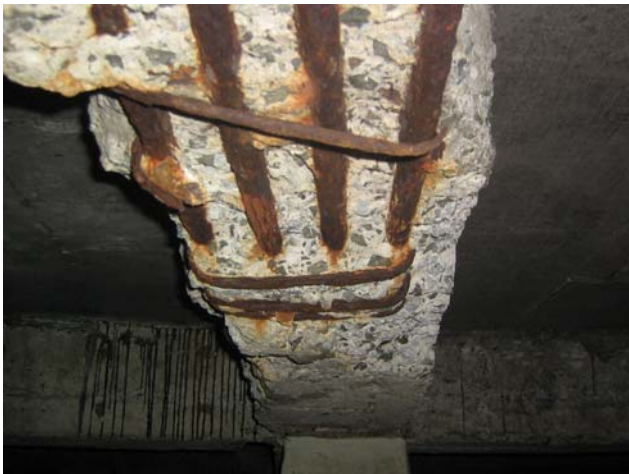
**Figure-9.** Typical view of the corroded/spalled beam.

All the spalled, cracked concrete and pre-applied mortars were removed by chipping to expose the reinforcing steel. The concrete was removed about 20mm behind the rebars. The repair sequence was so chosen that no two adjacent piles were chipped off at a time.

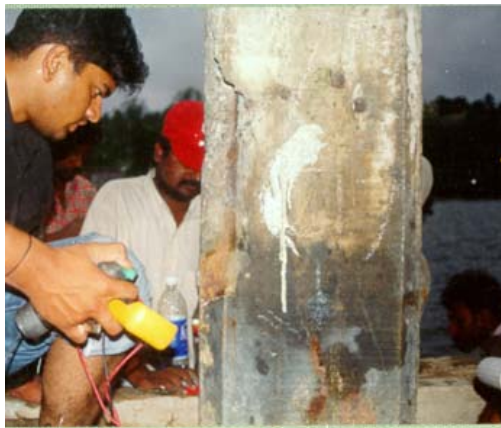
**Figure-10.** A view of the half cell potential test in progress on the pile before rehabilitation.

It is seen from the Table-4 that most of the readings show a value which is greater than -350 mV. As per Table-1, readings greater than -350 mV indicate a high probability of corrosion. At a few locations, the readings are more than -595mV confirming the severity of the corrosion. The half cell potential measurements coupled with the visual survey clearly demonstrate that the structural elements of the Fisheries jetty approach require immediate rehabilitation. The half cell potential readings in the piles and beams indicate that there is a high probability of corrosion in these structures, except few beams where the values indicated were around -200mV indicating uncertainty of corrosion. The half cell potential values obtained during the investigations prove that the corrosion is active.

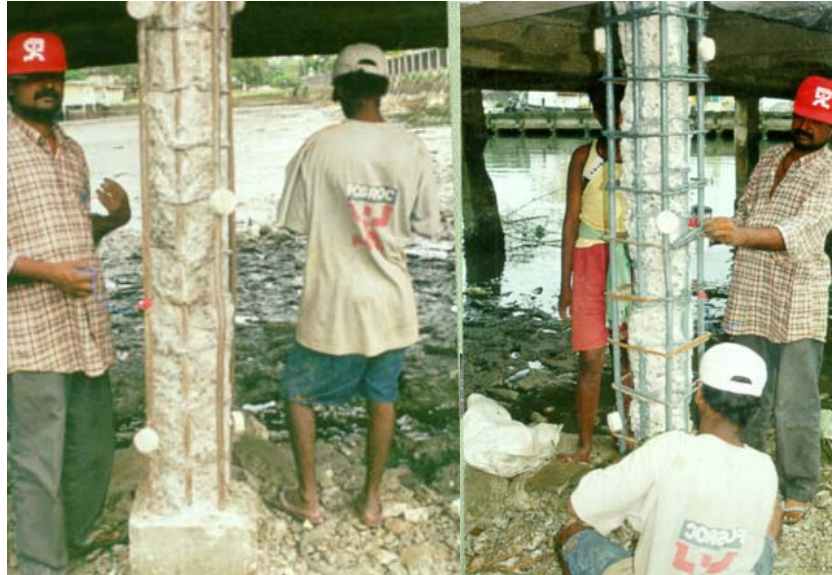
**Figure-11.** Typical position of galvanic anode and application of zinc rich primer.

Galvanic anode was positioned in such a way to ensure all round contact with the jacketed micro concrete and was attached to the existing/ additional reinforcement using the wire ties. Galvanic anode fixing tool was used to tighten the wire ties, so that no free movement was

possible, thus ensuring electrical continuity. Figure-11 shows a view of the fixing of galvanic anode to the pile. In order to check the electrical continuity between wire ties and reinforcement bar, a voltmeter was used.

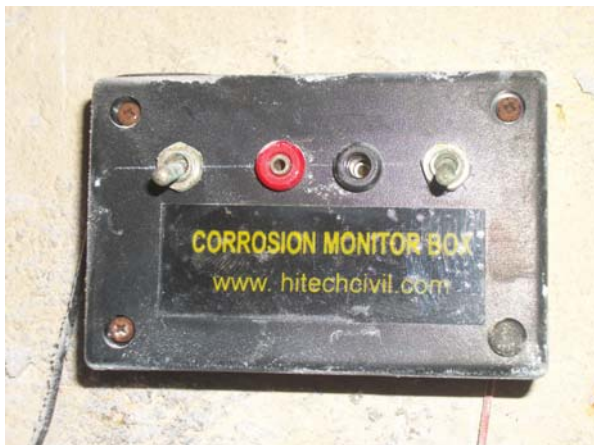
The number of galvanic anode to be provided in the micro concrete jacketed portion was determined based on the quantity of the steel provided in the micro concrete jacketed portion and as per the manufacturer's specification one number of galvanic anode per square meter surface area of the micro concrete. The connectivity was checked before and after installation of the galvanic anodes. Leads were taken from the steel and also from the sacrificial anodes to the junction boxes which were fixed on the surface of the micro concrete, so that the readings could be taken as and when required to monitor the corrosion potentials over a period of time to evaluate the efficiency of the Galvanic anode. Figure-12 shows a closer view of the corrosion monitoring box to be fixed on the surface of the jacketed portion for monitoring half cell potential readings over a period of time.

**Figure-12.** A view of corrosion monitoring box.

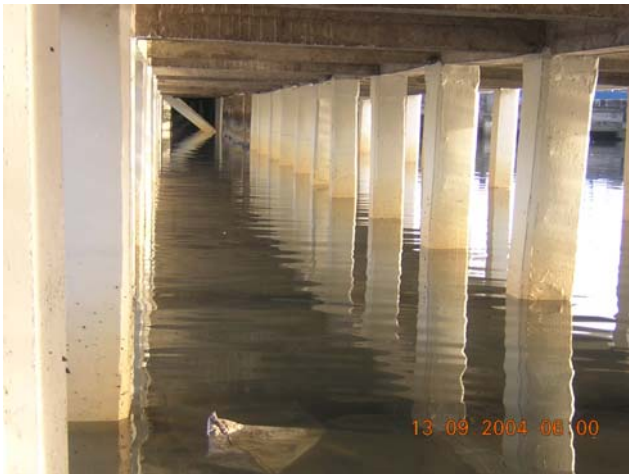
**Figure-13.** A complete view after the jacketing with under water micro concrete.

The members below water level were jacketed with under water anti wash and non shrink micro concrete of M45 grade. Above the high tide level, non-shrink free flow micro concrete of M45 grade was used. The micro concrete consisted of 12mm downgraded aggregates in the ratio 1:1 by weight. The jacketed members above the high tide level were coated with acrylic based curing compound immediately after the stripping of formwork. Figure-13 shows the completed view of the Fisheries jetty approach after jacketing with under water micro concrete.

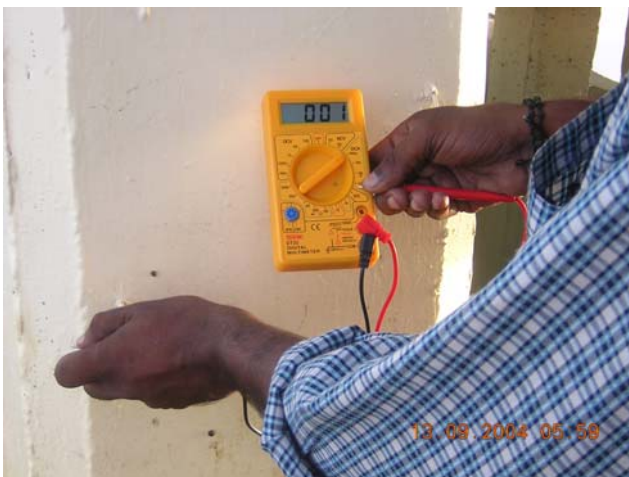
**Figure-14.** A view of the half cell potential test after the rehabilitation.

values more positive than  $-200$  mV at the end of 1 year and as per the recommendations of ASTM C-876 the rehabilitated structural members have high probability of no corrosion. Hence, it is clearly evident that the self regulating galvanic anode galvanic anode system is performing well in terms of corrosion protection.
