SEISMIC STRENGTHENING OF PARTIALLY INFILL RC BUILDINGS USING BRICK INSERTS - EXPERIMENTAL INVESTIGATION ON 3D MODEL STRUCTURE

R. Suresh Babu¹, R. Venkatsubramani² and G. S. Venkatasubramani²

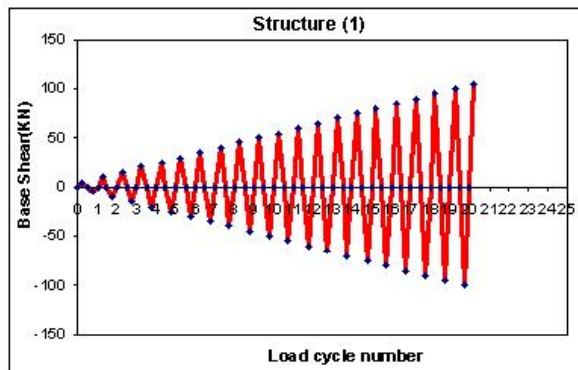
Figure-2. Sequence of loading for structure (1).

Lumped mass loads for top and bottom storey were calculated and applied on push and pull basis. Structure 1 was applied with 5kN push and pull load and released to zero and increased in steps of 5kN at every loading and releasing stages. Top storey deflections were measured using LVDT. The histories of sequence of loading for both structures are shown in Figures 2 and 3. The ultimate base shear of 105kN was reached in the Twenty first cycle of loading and ultimate base shear of 195kN was reached in thirty ninth cycle for structures 1 and 2, respectively. The formation and propagation of cracks, plastic hinge formation and failure pattern were recorded. This procedure was repeated for structure (2) with masonry insert.

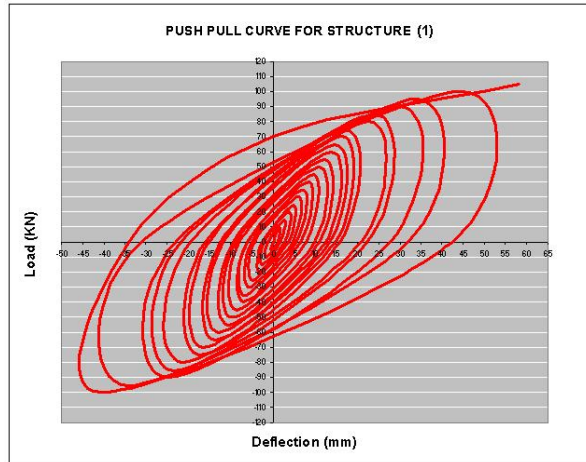
Figure-4. Push and pull curve for structure (1).

The structure was subjected to push and pull loading. The push and pull load was applied in increment of 5 kN base shear for each cycle and released to zero after each cycle. The deflections at top storey levels were measured using LVDT at each increment or decrement of load. The ultimate base shear of 105 kN was reached in the twenty first cycle of loading and ultimate base shear of 195 kN was reached in thirty ninth cycle for structures 1 and 2, respectively. The push pull curve for top storey displacement versus base shear for both structures is represented in Figures 4 and 5. At the ultimate base shear the top storey deflection was found to be 58.24mm for structure (1) and 71.15mm for structure (2).

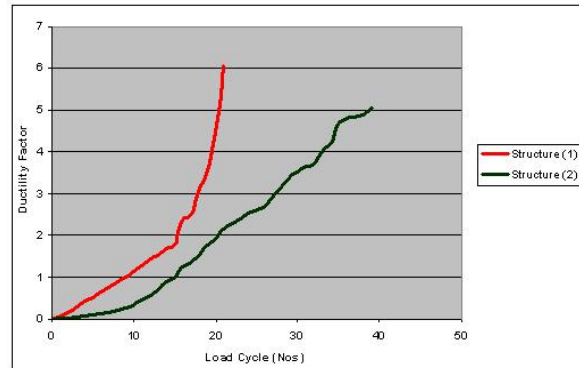
Figure-6. Ductility factor for both structures.

The ductility factor (μ) was calculated. For structure (1), the first yield deflection (Δ_y) for the load-deflection behaviour of the structure was found to be 9.605mm for 45 kN base shear, while for structure (2), the same is found to be 17.404mm for 80 kN base shear. The ductility factor value $\mu = (\Delta/\Delta_y)$ for various load cycles of the structures was worked out and the variation of ductility factor for both structures with load cycles are shown in Figure-6.

The ductility factor is found to be increasing more from 1 at ninth cycle to 6.06 at twenty first cycle for structure (1). While for structure (2), the ductility factor is 1 at sixteenth cycle of loading and only 4.08 at thirty ninth cycle of loading. This behaviour shows the reduction of ductility of structure due to the provision of masonry insert and is shown in Figure-6.

The ductility factor value $\mu = (\Delta_1/\Delta_y)$ for various load cycles of the structure is worked out for structures with and without insert and the variation of ductility factors for both structures with reference to load cycles is plotted. From the values, it is noted that ductility factor for structure with masonry insert is reduced.

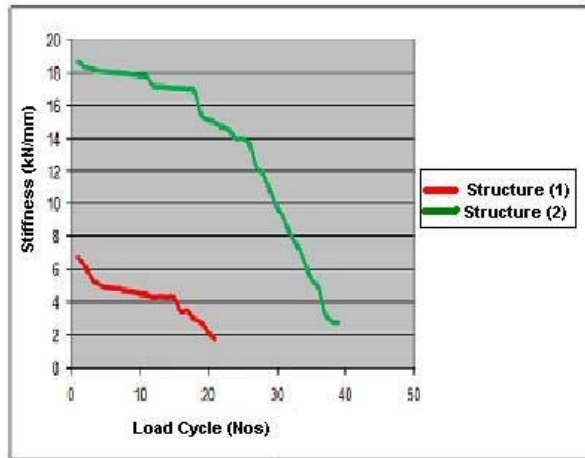
Figure-7. Stiffness degradation curve for both structures.

The stiffness of the partially-infilled structures for various load cycles is calculated and presented. The variation of stiffness with respect to load cycles is shown in Figure-7. For structure (1), it may be noted that stiffness decreases from 6.7kN/mm in first cycle to 1.8 kN/mm in twenty first cycle. A sudden reduction in stiffness takes place after the first crack occurrence in 45 kN load.

For structure (2), the initial stiffness of structure is 18.69 kN/mm against 6.7 kN/mm of the first structure and stiffness is sustained for a longer duration until the development of first crack and is reduced to 2.74 kN/mm in Thirty nine cycle.

This behaviour shows that the initial stiffness of structure (1) is comparatively very low and flexural hinges and shear cracks are developed at an early stage of loading. For structure (2) with masonry insert, initial stiffness is increased and occurrence of flexural hinges and shear cracks in concrete and masonry takes place only after the sixteenth cycle. Also, it could be noted that the initial stiffness is increased by 2.8 times due to the introduction of masonry insert and the stiffness is sustained for a longer duration of loading. The behaviour of structure for stiffness values is shown in Figure-7.

The stiffness of the partially-infilled structure with and without insert for various load cycles is calculated and the variation of stiffness with respect to load cycles is plotted. The stiffness of the brick infilled RC structure with masonry insert is observed to be very high when compared to structure without insert. This shows greater increase of stiffness while introducing masonry insert.

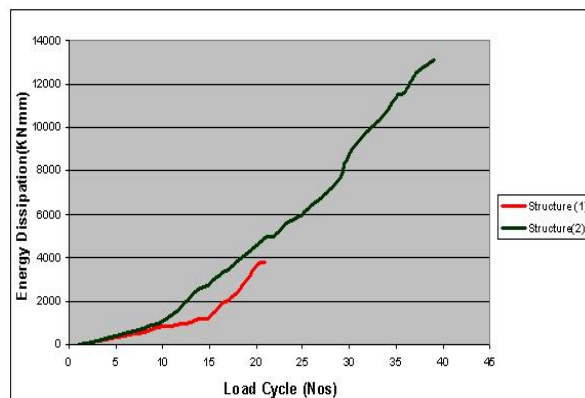
Figure-8. Energy dissipation capacity curve for both structures.

The energy dissipation capacity of the structure during various load cycles were calculated as the area bounded by the hysteresis loops from the base shear versus top storey deflection diagram for structures (1) and (2). The energy dissipation in the structure (1) is 3780 kNmm whereas the energy dissipation in structure (2) is 13120 kNmm. This is due to the masonry insert provided in structure (2), which means the structure can dissipate more energy under lateral loading. The energy dissipation curve behaviour for structures (1) and (2) is shown in Figure-8.

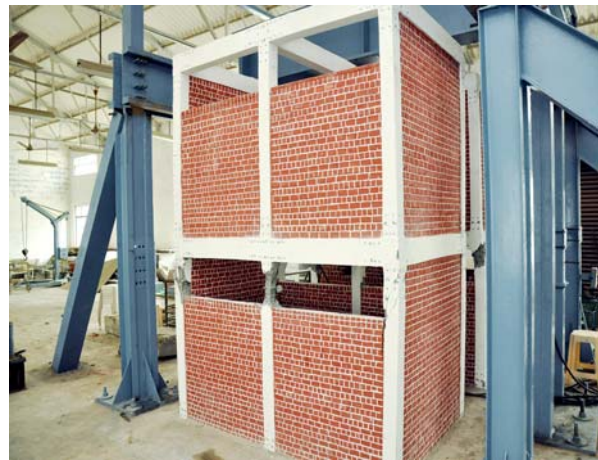
Figure-9. Test structure (1) with failure in the bottom and drift of the top storey (Constructed at VLBJCET, Coimbatore).

First crack was observed (horizontal hairline) at 45kN at the junction of loaded side of the beam and column at the bottom storey, where moment and shear forces are maximum. While loading further, similar cracks were developed in the other bay columns and flexural cracks were developed from the junction of the loaded area. Separation of infill occurred at the tension corners. At the ultimate failure load of 105 kN, crushing of loaded

corner, widening of diagonal cracks in columns and infill, layer separation of brick infill were also observed. Width of the cracks was ranging from 3mm to 17mm in concrete and masonry. The crack pattern indicated a combined effect of flexure and shear failure. Also plastic hinges formation was observed first at loaded point and later to the middle column and finally at the leeward column. Captive column phenomenon was identified with the failure pattern of loaded column. It was also noticed that flow of diagonal crack from the loaded column adjacent to the opening was discontinuous, due to incomplete strut action (Figure-9).

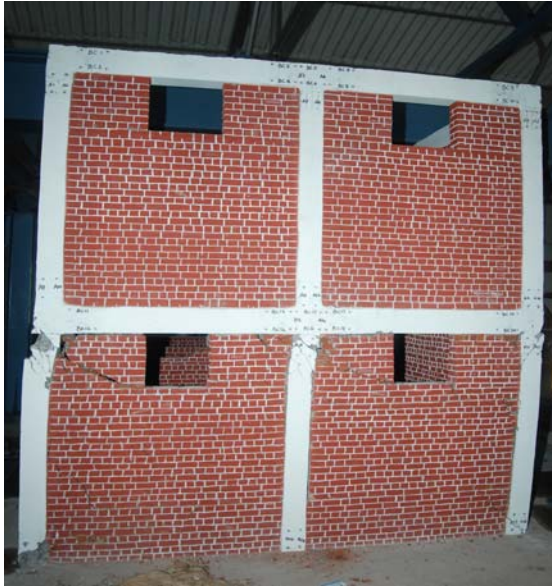
Figure-10. Test structure-2 with failure in the bottom and drift of the top storey (Constructed at VLBJCET, Coimbatore).

First crack was observed (inclined downwards) only at 80 kN, (against 45 kN for the structure without insert) at loaded side of the beam and column junction of the bottom storey where moment and shear forces were maximum. While loading further, similar cracks were found to propagate in middle column beam junctions and diagonal cracks were initiated in the first (loaded) bay. Further, diagonal cracks were seen to flow through the brick infill. Separation of infill occurred at the tension corners. Due to the presence of insert, diagonal cracks were observed to flow from the loaded beam - column junction to the diagonally opposite corner, clearly depicting the expected strut action (Figure-10). At ultimate load of 195 kN, plastic hinge formation and failure of structure at all bottom storey junctions were noticed. The width of the cracks was ranging from 2mm - 10mm in concrete and masonry. The crack pattern indicated a combined effect of flexure and shear failure and the direction of flown crack showed the developed strut action through the brick infill, due to the presence of masonry insert.

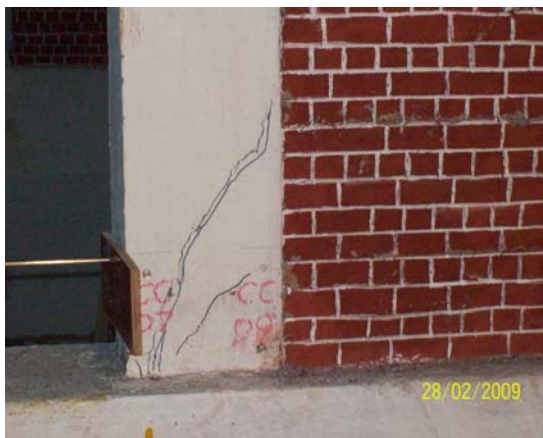
Figure-11. Crack in leeward column.

A crack in leeward column of the bottom storey at the base was also observed (Figure-11). Separation of infill occurred at the tension corners and the high stress concentration at the loaded diagonal ends led to early crushing of the loaded corners (Figure-12).

It is also evident from the propagation of cracks at bottom storey level of the sixteenth cycle (80 kN Base shear). Cracks in tension face of leeward column were developed after twenty first cycle of loading. Also separation of infill from columns at highly stressed tension faces of column was seen at twenty first cycle of loading. Further, shear flow was observed in structure 2 from the columns through the insert and brick infill, creating a largely visible crack (about 12mm wide), which is extended to the adjacent columns. This phenomenon is clearly exhibits the development of strut action through masonry inserts.

Cracks were developed in the leeward column (both side of the loaded end) of the bottom storey at the base because of diagonal strut compression of the infill in the structure with masonry insert.

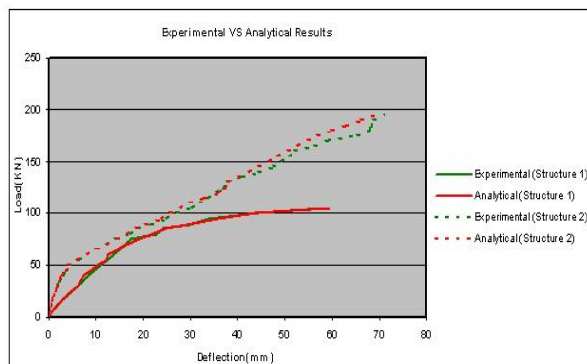
Figure-15. Comparison of base shear Vs top storey deflection for structure 1 and 2 with experiment and ANSYS results.

The results obtained from analytical by ANSYS-10 for Structures (1) and (2) are compared with experimental results and the variation is marginal (Figure-15).

In analytical study, it is noticed that a sudden increase in deflection after the base shear of 45 kN (nearly equal to experimental value of 45 kN) for Structure (1) and affect the base shear of 80 kN (nearly equal to experimental value of 80 kN) for Structure (2). This proves the initiation of captive column behaviour adjacent to gap region.

Analytical results by ANSYS-10 variations are marginal when compared to experimental results.
