INTERNAL CRACK ASSESSMENT ON CONCRETE STRUCTURES BY SCANNING IMAGE ANALYSIS

A. Zacoeb¹, Y. Ito² and K. Ishibashi²

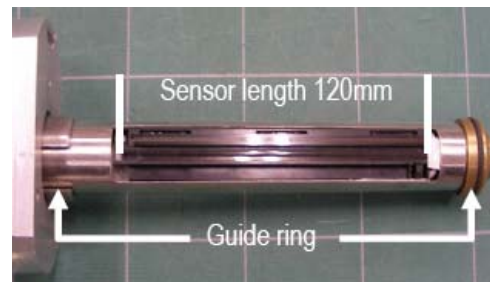
Figure-3. Sensor.

Sensor part as shown in Figure-3 is having a sensor length of 120mm and resolution of 600DPI. The stick scanner sensor has a CIS type with focus depth of 1mm. In order to keep the focus length, as the distances of surface inspection borehole with the scanning sensor are changeable, a pair of guide rings and scanner aperture mouth was established to support a stable rotational movement. The guide ring diameter is assumed to be 1mm

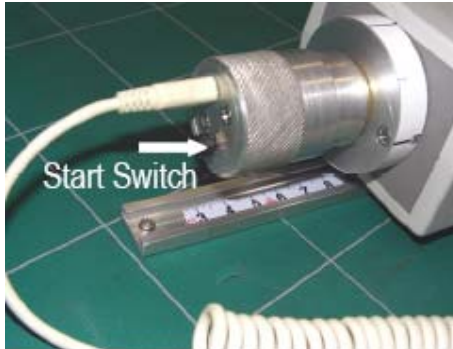
Figure-4. Rotation knob.

Although hand partial or supporter grip is a little hard to grab, it has a smooth configuration which curved so that a system could be supported enough on the examination object. Rotation knob part as shown in Figure-4 has a ruler and degree of rotation guide for confirming the insertion length and rotation direction of sensor. A rotation of sensor is manual and internal surface image capturing process can be conducted by pressing the

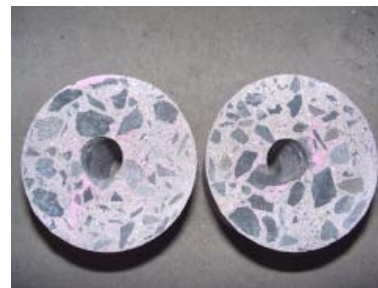
Figure-7. Cylindrical specimens.

Accuracy of crack width measurement is examined by cutting a cylinder specimen with an inspection drilled hole into two equal parts as shown in Figure-7. Artificial crack is created by inserting a spacer block between two test specimens and supporting in fixed position as shown in Figure-8. The crack widths that had been analyzed were 0.05, 0.1, 0.2, 0.4, 0.5, 0.6, 0.8, 1.0, 1.5, 2.0, 3.0, 4.0, and 5.0mm. The calculation method of crack width was confirmed by counting the pixels number of cracking part from the representation image is shown in Figure-9.

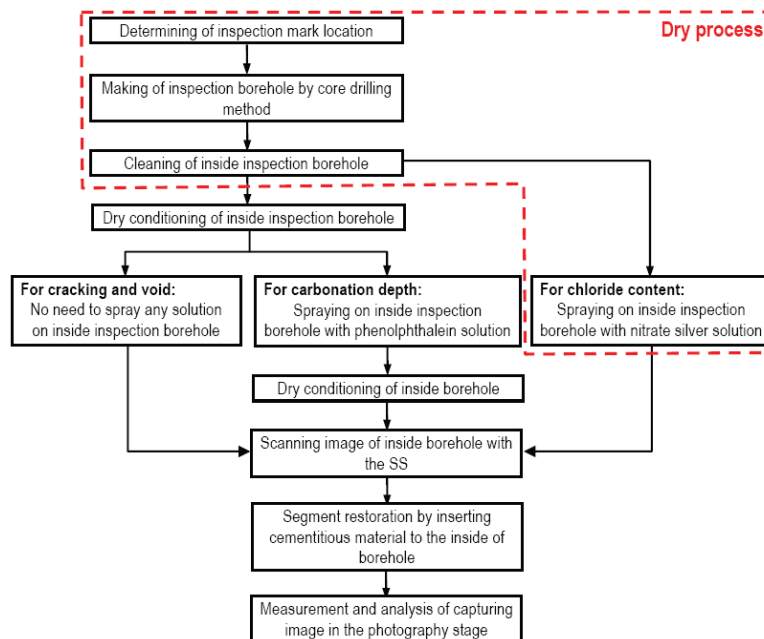
Figure-12. Flowchart of various inspections.

Reinforcing bar investigation is performed in the first stage by a cover meter to determine a drilling location and avoid a reinforcing bar cutting accident. Investigation of internal defect such as cracking or void is possible by scanning image after having sprayed with phenolphthalein solution for carbonation depth measurement in dry or wet core drilling process. While for chloride ion diffusion, it must be performed in dry process and sprayed with nitrate silver solution (AgNO_3). The measurement is possible by calculating a number of pixels in the scanning image part with color changes after having sprayed with the solution. The scanning process is conducted after dry conditioning of inspection borehole. Inspection procedure with this scanner, from reinforcing bar investigation to the segment restoration for various investigations with this device is shown in Figure-12.
