MANAGEMENT OF RISK THROUGH SEEPAGE REDUCTION FOR TWO EARTH DAMS IN KURDISTAN REGION, IRAQ

Sangar Hasan Abdulkareem, Thamer Mohamed Ahmed and Abdul halim Ghazali

Department of Civil Engineering, Universiti Putra Malaysia, UPM Serdang, Selangor, Malaysia

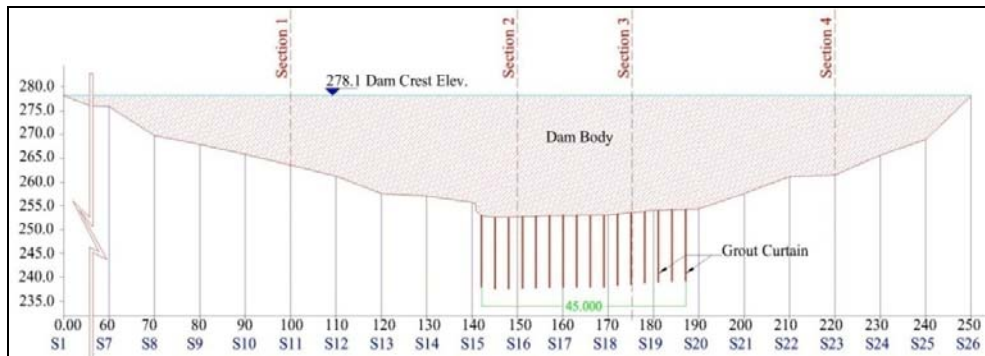
Figure-2. Location of Grot Curtain on longitudinal section of Bawashaswar Dam.

claystone, and is covered by 4 m quaternary sediments which are composed of a mixture of gravel and sand at the mid valley. For further safety of dam, a single line of 15 m

deep grout curtain was constructed beneath the dam centerline as shown in Figure-2.

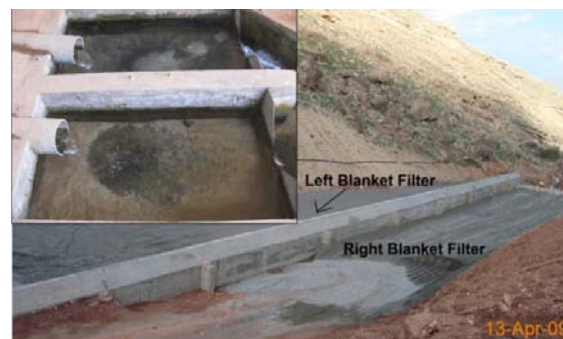
Figure-7. Blanket filter and v-notch chamber at Hamamuk dam.

The main components of the embankment are central core, shell and blanket filter. The core zone is specified as a mixture of clay, silt and sand. The shell of the dam consists of a mixture of gravel and sand with a small ratio of silt and clay. The embankment design includes a 60 cm filter as a transition zone separating clay core from the shells. A 60 cm thick gravel and sand blanket drain was constructed beneath the entire downstream shell as shown in Figure-7. The bottom outlet pipe divides the blanket filter into two separate parts. Thus, the v-notch measurement chamber is divided in two parts.

The drainage system is designed to separate the seepage of the dam's left side from the seepage of the dam's right side along the diversion channel as shown in Figure-7. But it is found that the design was not working and the seepage from both sides is mixed due to construction defects as shown in Figure-17.

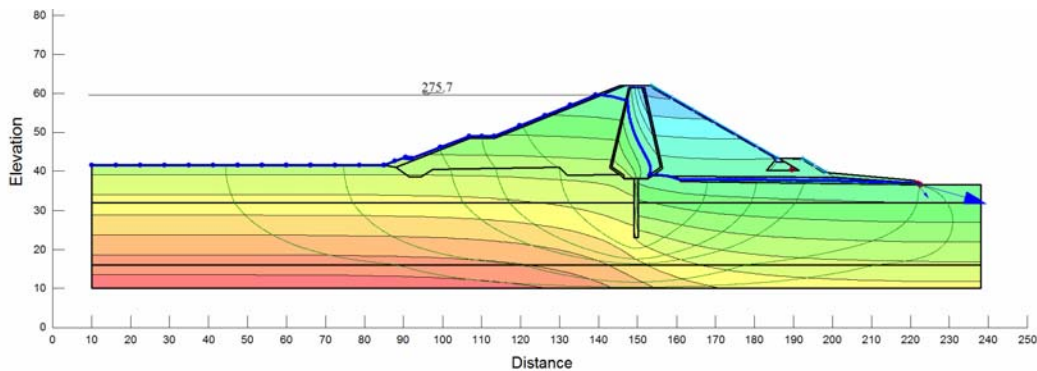
Figure-11. Modeling of Bawashaswar dam within recent deposit stratum beneath bottom outlet gallery.

SEEP/W model was carried out to find the effects of this stratum on seepage path through and beneath the dam and another condition was simulated where the recent deposits are not considered in the dam body. The result indicated that during filling of the reservoir, the recent deposits was worked as a blanket filter at the dam downstream as shown in Figures 10 and 11. As a consequence, the drainage arrangement is not functioning because the drainage pipe is located at an elevation higher than the phreatic line.

Also, the models show that seepage rate increased by about 21% due to the effect of recent deposits on decreasing length of seepage path through and beneath the dam. Generally, measures to control seepage include cutoff walls for reducing the seepage rate and decreasing the exit gradients, and drainage or relief structures increase flow rate but reduce seepage pressure (USACE, 1993).
